NIH CBM improves City Water Pump in National Library of Medicine

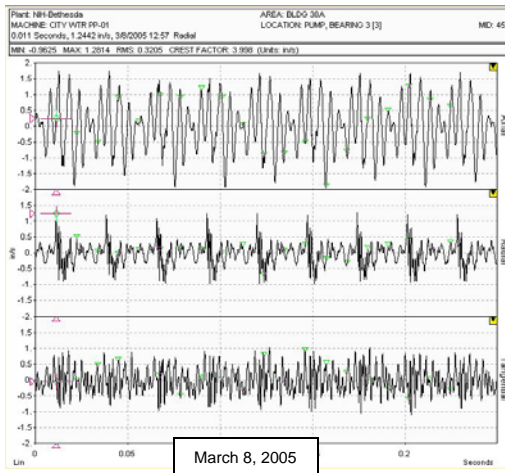
Todd Loveless requested NAVSEA TEAMM assistance to evaluate an unusual noise coming from the city water pump number #1 in building 38A. Vibration analysis indicated a condition of looseness and the Ultraprobe 9000 pinpointed the problem at the coupling. Below at left, you can see the actual waveform taken from this water pump on March 8, 2005. This shows a severe vibration that needed to be addressed immediately. The waveform showed a peak vibration of nearly 1.0 inches per second. The center spectrum, from the radial direction, also indicates an impact, or heavy hit, once per revolution of the shaft.

George Peters and Todd Loveless disassembled the coupling. Contact between the motor half key and the face of the pump coupling hub along with a significant misalignment of the shaft were found to be contributing factors to the vibration. The coupling was reassembled after relocating the shaft keys, and a recommendation was made to realign the pump, and documented into the TEAMM online system.

On March 15, 2005 George Peters and Ken Gilliam of NAVSEA realigned the pump. With the motor alignment being out as much as 95 thousandths, shims were installed to bring the alignment down to just 4 thousandths.

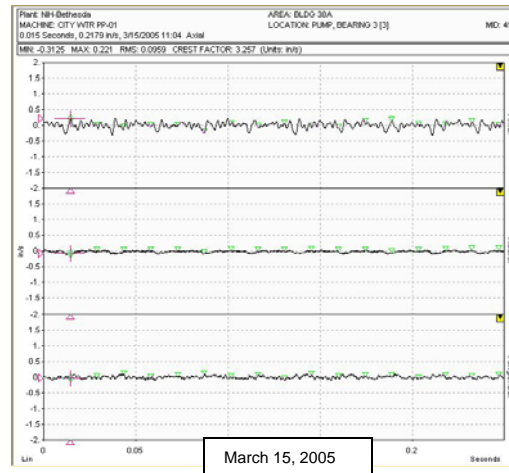
Vibration measurements were taken after the alignment and the resulting waveform is shown above, at right. The scale on this spectrum is the same as the spectrum on the left. This pump is now running at acceptable vibration levels and the exception has been closed within the TEAMM system. Without these corrections, this pump would have ultimately suffered a catastrophic failure.
